## 2019-2020 ACT ENVIRONMENT GRANTS PROJECT EVALUATION AND FINANCIAL REPORT

**Project Title:**            Bringing Biodiversity Back to Canberra Suburbs

**Grant Recipient:**        Molonglo Conservation Group

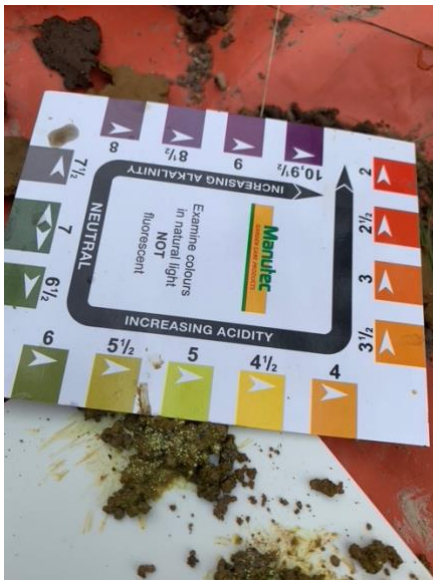
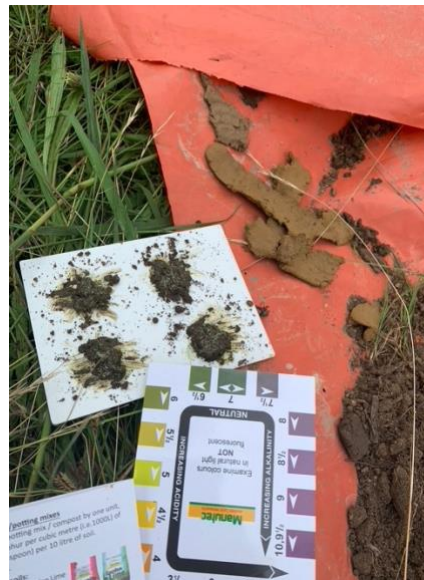
**Soil texture**

**Soil Ph**

Left: soil sampled from the centre of park.

Testing took place on 29/01/22. Soil was tested in two parts of the park in the middle and three quarters of the way to the top of the park.

In terms of acidity Ph ranged from 5 – 7 moderately acidic to neutral considered good conditions for plant growth. A general description of colour indicated brown, grey-brown and yellow-brown. In terms of texture soil tested was clay loam with a higher gravel content when sampled close to the top of the way to the top of the park.

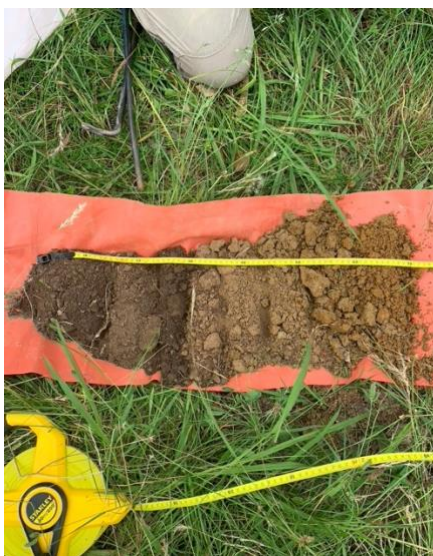
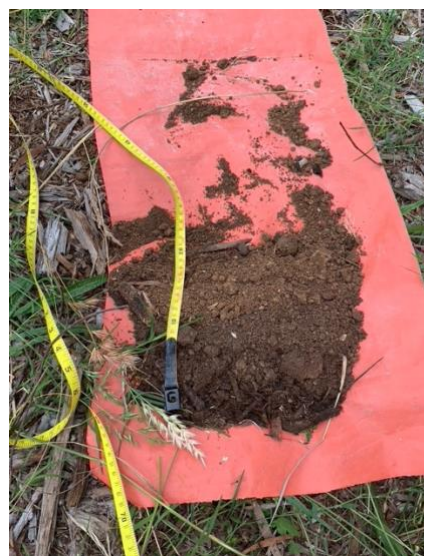
Left: soil sampled from centre and near the top of the park.

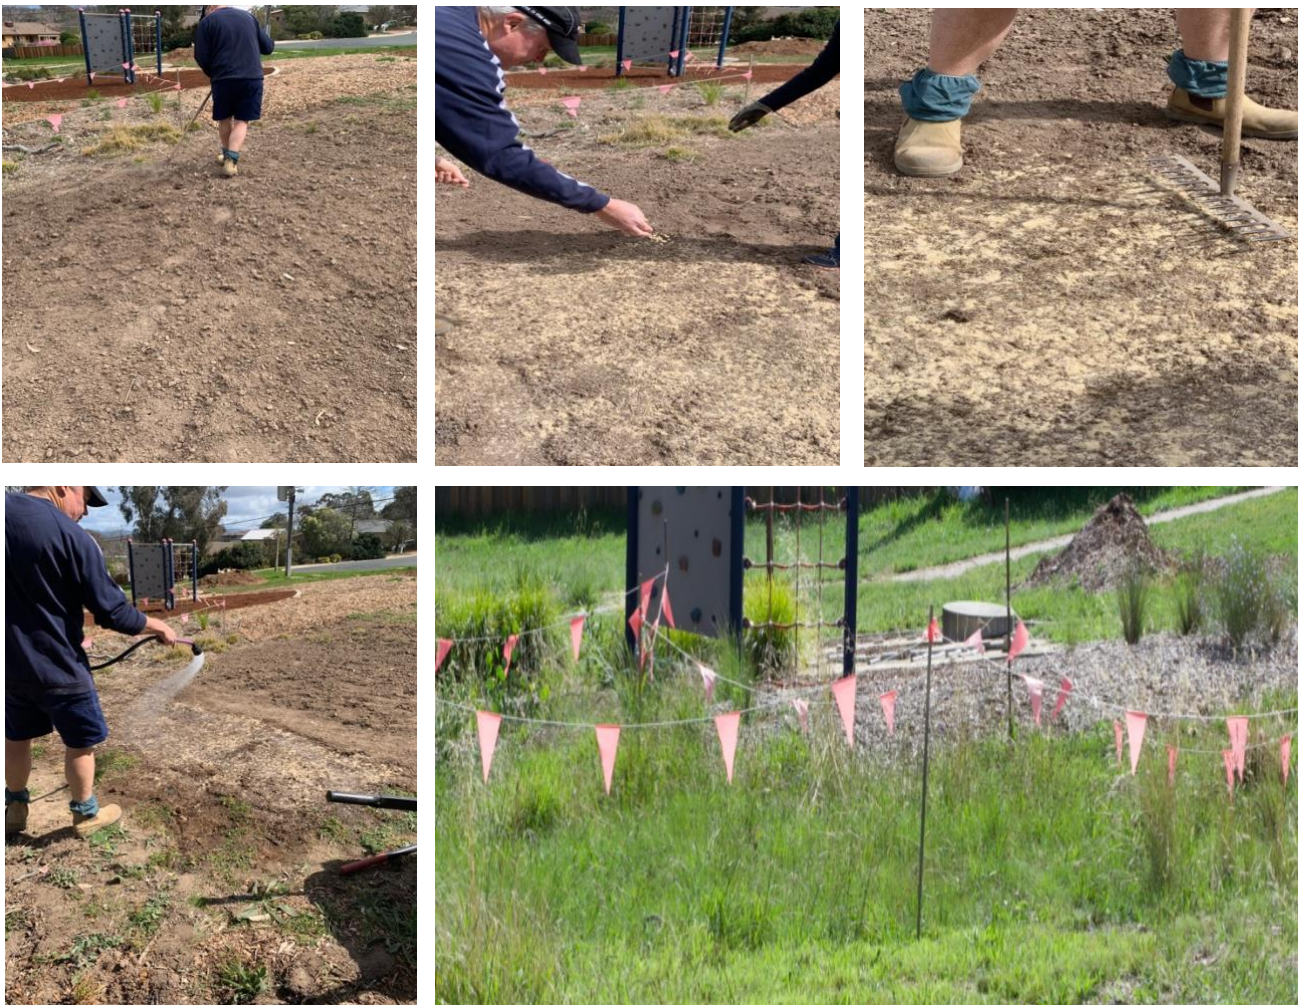
Seeding of native grass seed was done in two plots of approximately 2m X 2m without top-soil, added to see if traditional preparation on native soil where only a few cm was raked from the top. Native seed was applied liberally with a light sprinkling of sand would allow native grasses to germinate.

We found the native grass seed including *Austrostipa Bigeniculata* and various wallaby sp germinated readily enough however ALG also germinated freely and was recorded frequently.

Methods used for exotic grass seed including the removal of the top 5cm of soil was insufficient to allow native grasses to dominate the ALG seed bank. Given the persistent nature of the ALG seed bank funds for top soil were spent on forest tubes.
